TP 14170E
LIFERAFT SERVICE INTERVAL EXTENSION

Prepared for
TRANSPORTATION DEVELOPMENT CENTRE
TRANSPORT CANADA

by
MIL   **Systems**
(DAVIE INDUSTRIES)
22 George-D.-Davie
Levis, Quebec
G8V 6N7

September 2003

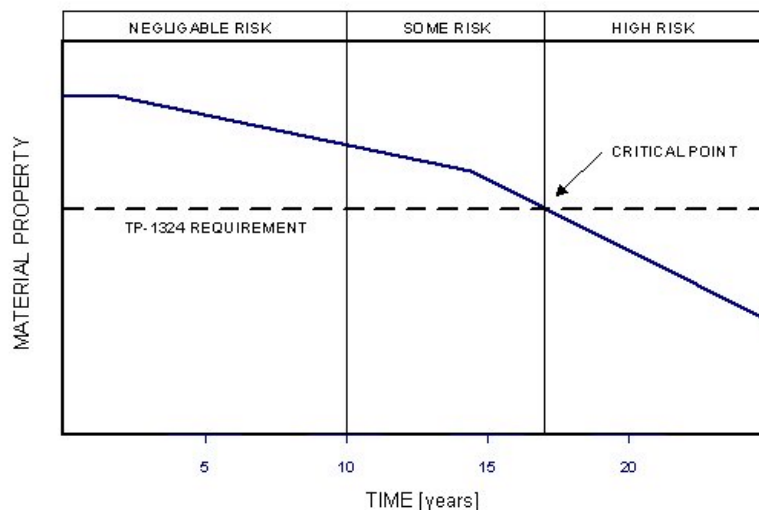
Figure 4.1 Lifesaving Reliability v. Time

Change to the lifesaving reliability of a liferaft over time (age of the liferaft) depends on how the liferaft material properties change with time. Figure 4.1 illustrates the theoretical question being addressed.

By observing the change in material properties over time, it is possible to estimate when material properties would fail to meet the TP-1324 requirements (the critical point on Figure 4.1).

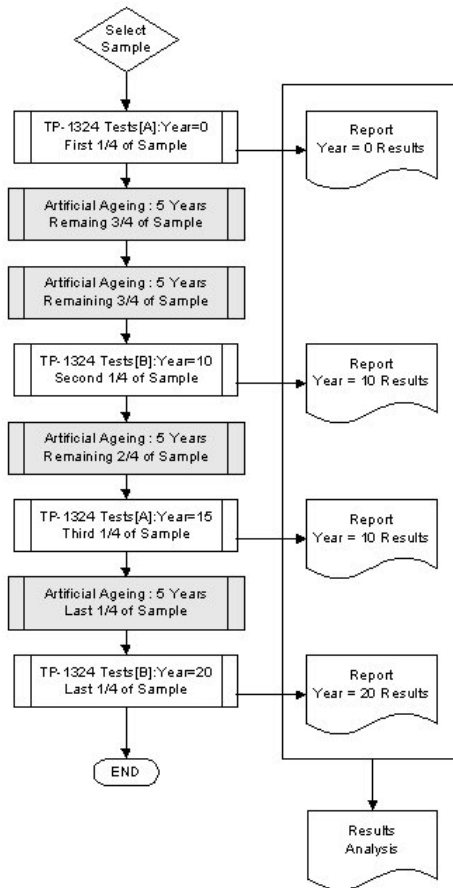
Figure 5.2 Accelerated Ageing Materials Testing Program

Table 5.1 below identifies the material properties test results obtained from each sample. The test process is shown schematically in Figure 5.2 above. TP-1324[A] noted in this figure indicates the sub-set of tests identified in [A], while TP-1324[B] indicates the same plus the Low Temperature Flexing (TP-1324, 3.2.9) test.

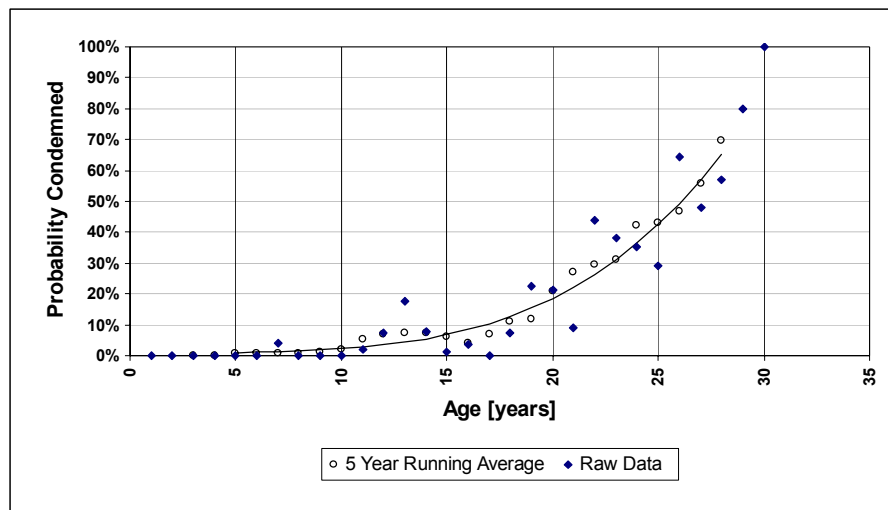
Figure 6.6 Condemned Probability Plot: Non-Annual Inspections

To infer the probability that a liferaft of a given age will be condemned, the total database must be analyzed. With the current database (limited number of inspection forms for certain ages), some data filtering must be done before analysis can be done. Figure 6.6 below plots the percentage of liferafts that were Condemned v. Liferaft Age. This scattered raw data may be filtered using a 5-year running average; also plotted on Figure 6.6 for liferaft ages of 3 to 28 years. A 4th order polynomial series fit to this filtered data (shown as solid line) yields the equation for Condemned Probability:

Using this formula, we can infer that the probability of condemning a liferaft during inspection is as follows:

- 0.9% for a five-year-old liferaft
- 2.3% for a ten-year-old liferaft
- 6.8% for a 15-year-old liferaft
- 18.5% for a 20-year-old liferaft

Using a similar five-year filter and polynomial fit method to that of deriving Condemned Probability illustrated by Figure 6.6, one can arrive at Critical Problem Probability v. Liferaft Age. Figure 6.13 shows that the probability of a critical problem occurring is ~5% at less than four years of age. The probability rapidly increases with age past four years and peaks at 16 years, with the bulk of

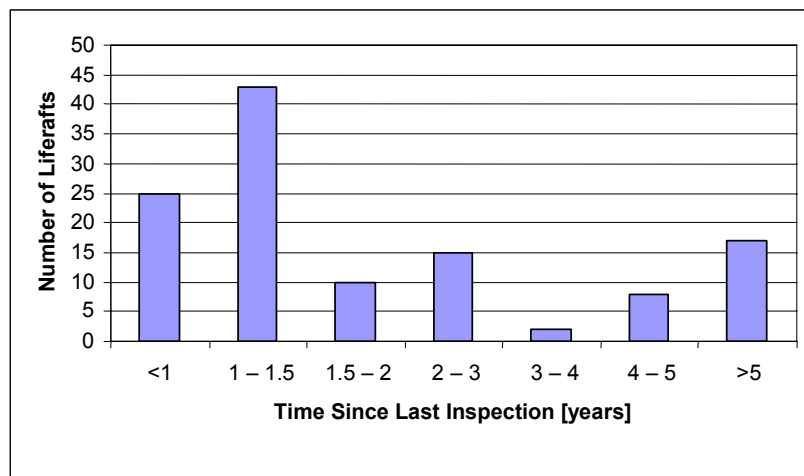
Table 6.2 also shows the average service interval for each dataset. Of particular interest is the difference between the average for serviceable liferafts (530.5 days) and condemned liferafts (1006.0 days). This indicates liferafts that have been condemned have had comparatively poor inspection histories.

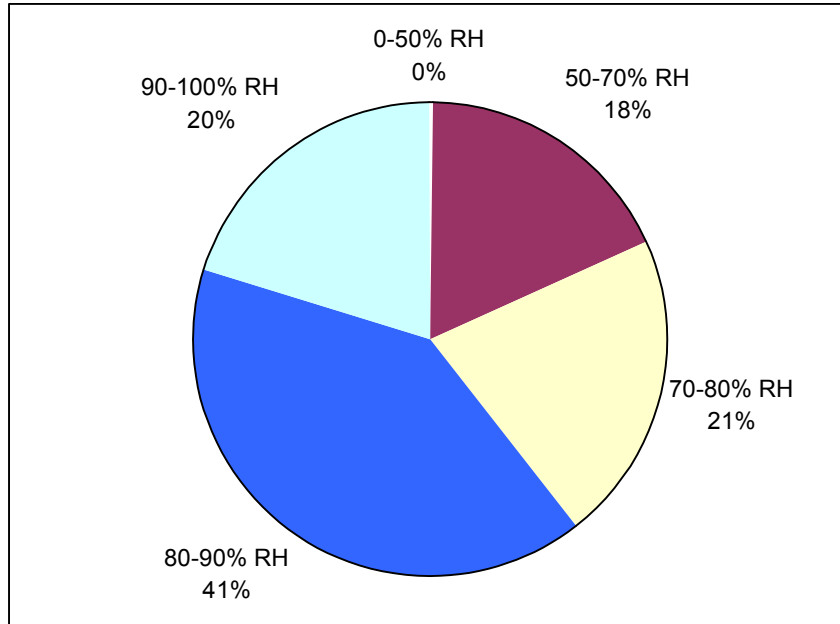
According to Figures 6.14 and 6.15, liferafts across Canada are exposed to temperatures of 10 – 20°C for ~50% of the time and temperatures of 0 – 10°C for another 30% of the time, while they are exposed to relative humidity (RH) of 80-90% for ~40% of the time, RH 70-80% for ~20% of the time and RH 90-100% for ~20% of the time. In addition, the ShockLog indicated that typically liferafts experienced negligible motion. However, the average non-zero acceleration was ~0.2g in X, Y and Z directions. Acceleration distribution is illustrated in Figures 6.16 – 6.18. This is not believed to put undue stress on the liferaft materials or canister.

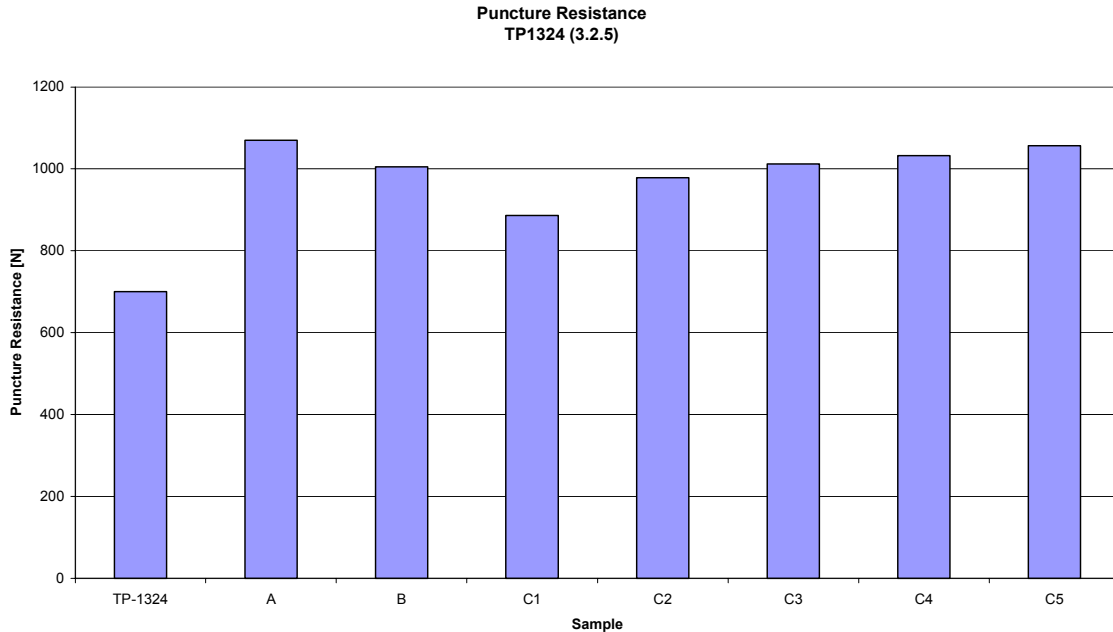
The test results shown in the above figures indicate that the material properties all exceed TP-1324 requirements and do not change significantly with time. However, Table 6.4 indicates that a number of materials failed the Flex Cracking test. These same materials passed standard liferaft inspections without problems and otherwise pass all TP-1324 requirements. These incongruent results may be an indication that the Flex Cracking requirement, as outlined by the TP-1324 document, is too stringent and may require re-evaluation. In all other respects, the results revealed little change in material properties and whatever change observed is believed to be within the variance expected in material sampling and testing.

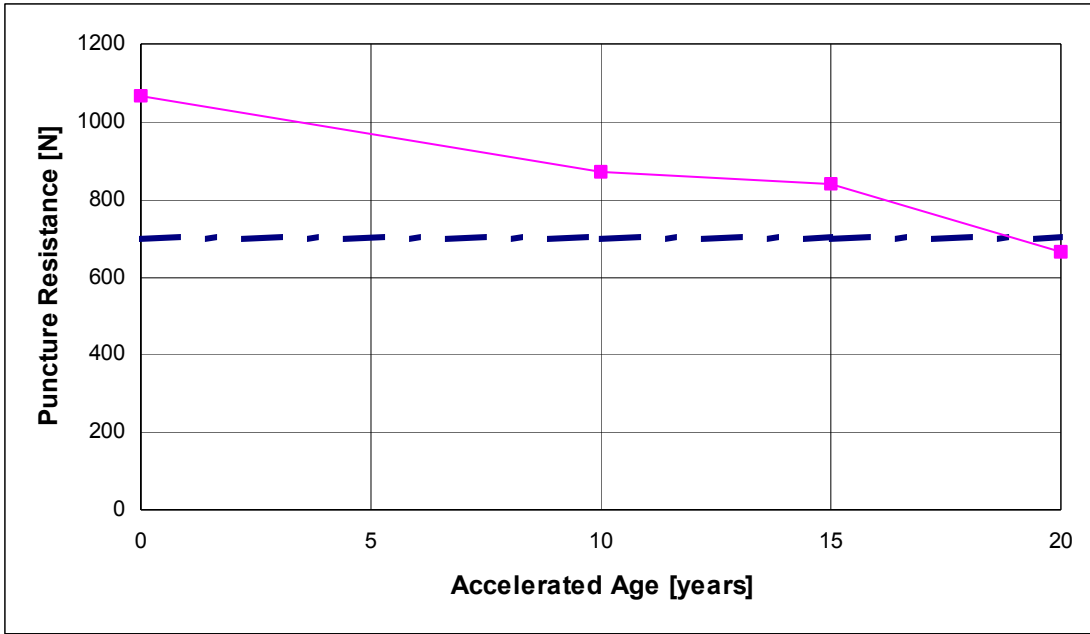
Figures 6.23 – 6.27 show plots of Material Properties v. Artificial Age (0, 10, 15 and 20 years) for Weight, Breaking Strength, Elongation at Break, Tear Strength and Puncture Resistance respectively.

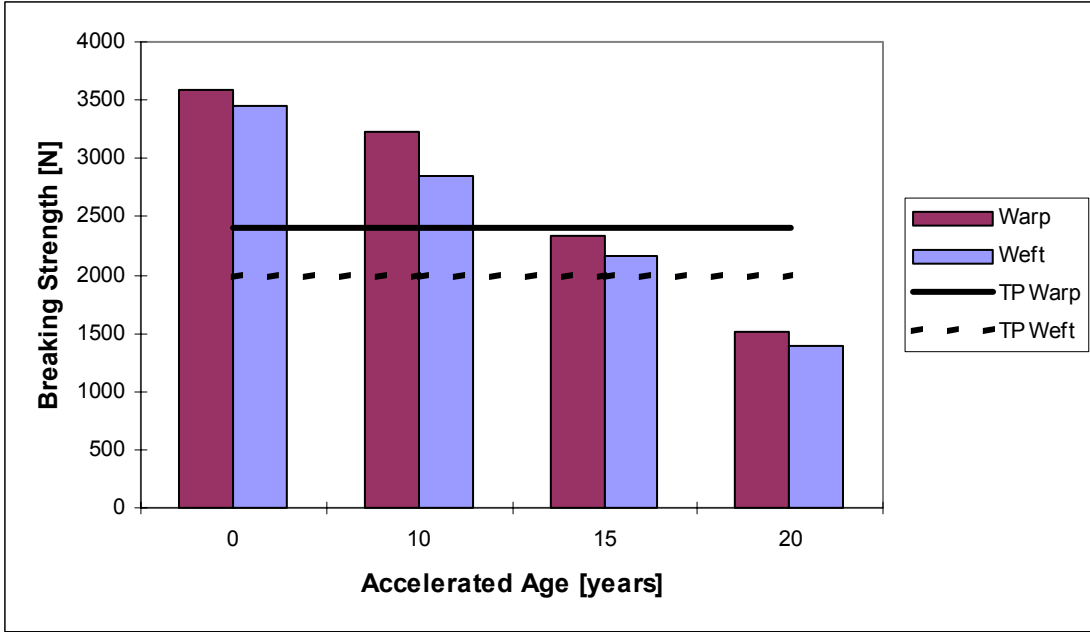
Figures 6.28 – 6.32 show plots of Material Properties v. Artificial Age (0, 10, 15 and 20 years) for Weight, Breaking Strength, Elongation at Break, Tear Strength and Puncture Resistance respectively.

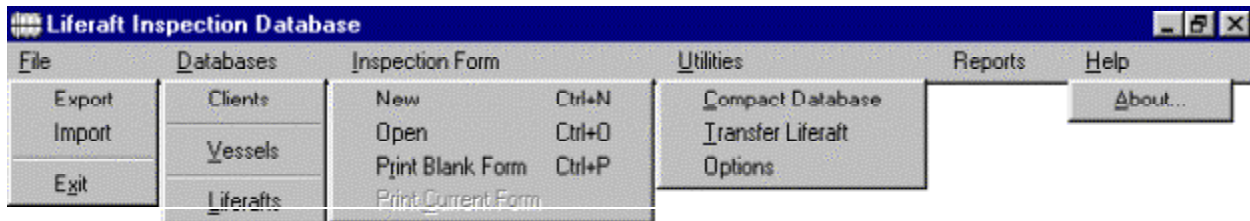
6.2 Main Menus

The LIDS program consists of six menus, shown below. A brief functionality summary of each menu item is provided below. Details are provided in the following sub-sections.
